Update from DUNE Laser Lab at LANL

DUNE-IoLS Meeting

Mattia + Laser crew (Eric, David, Sowjanya) - June 08, 2022

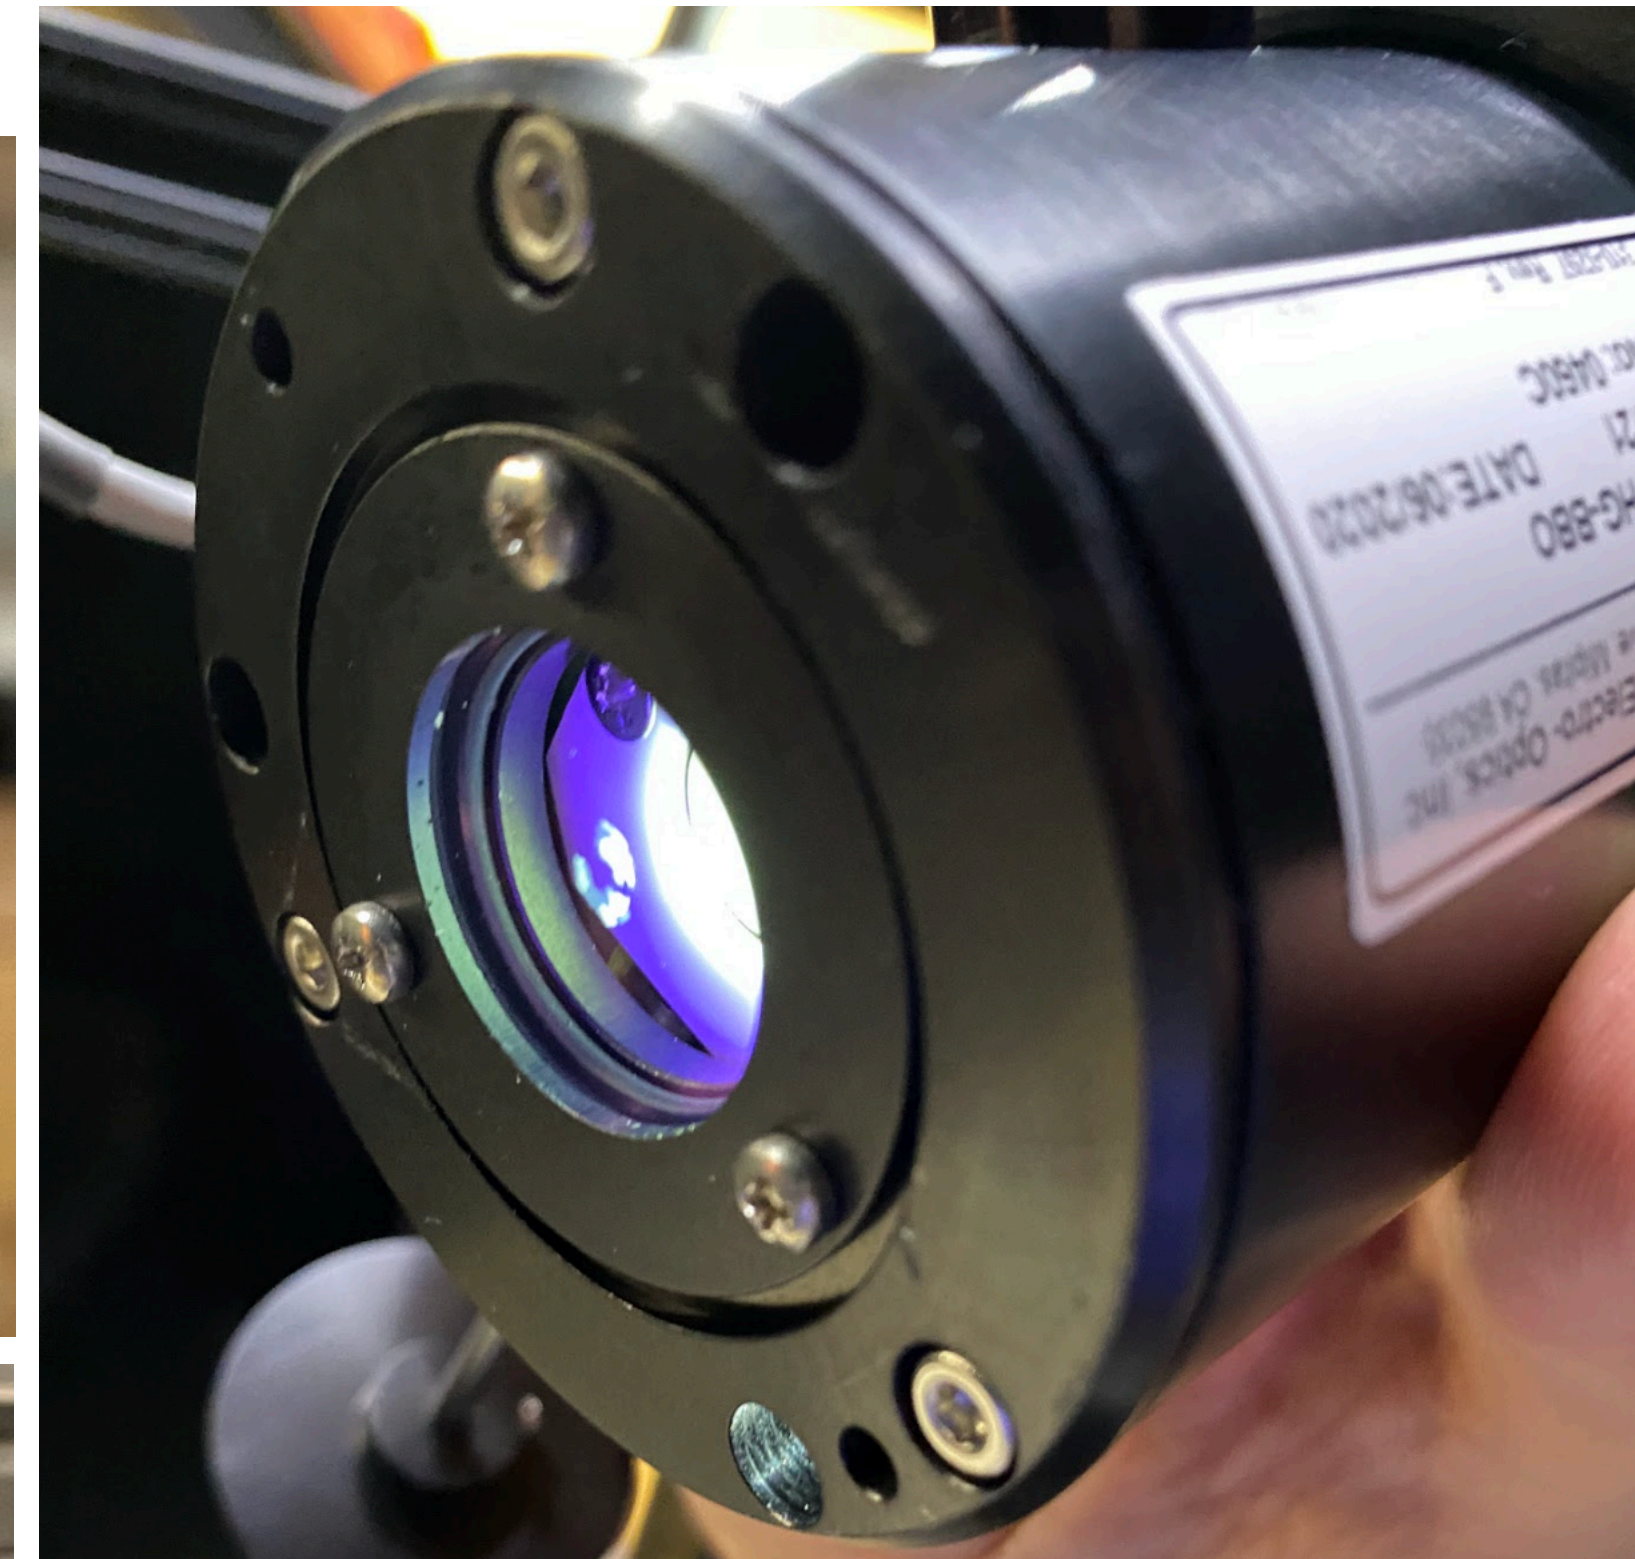
The usual movie

- FHG exit window looks damaged
- Unlike last time, FHG entrance window looks still okay
- Some dust inside the laser bench
- M2 collected 2 additional marks in the first two days of resumed activity
 - We realigned to a new spot after day 1 - still there since then
- No difference with the status of other optics (Attenuator, mirrors)

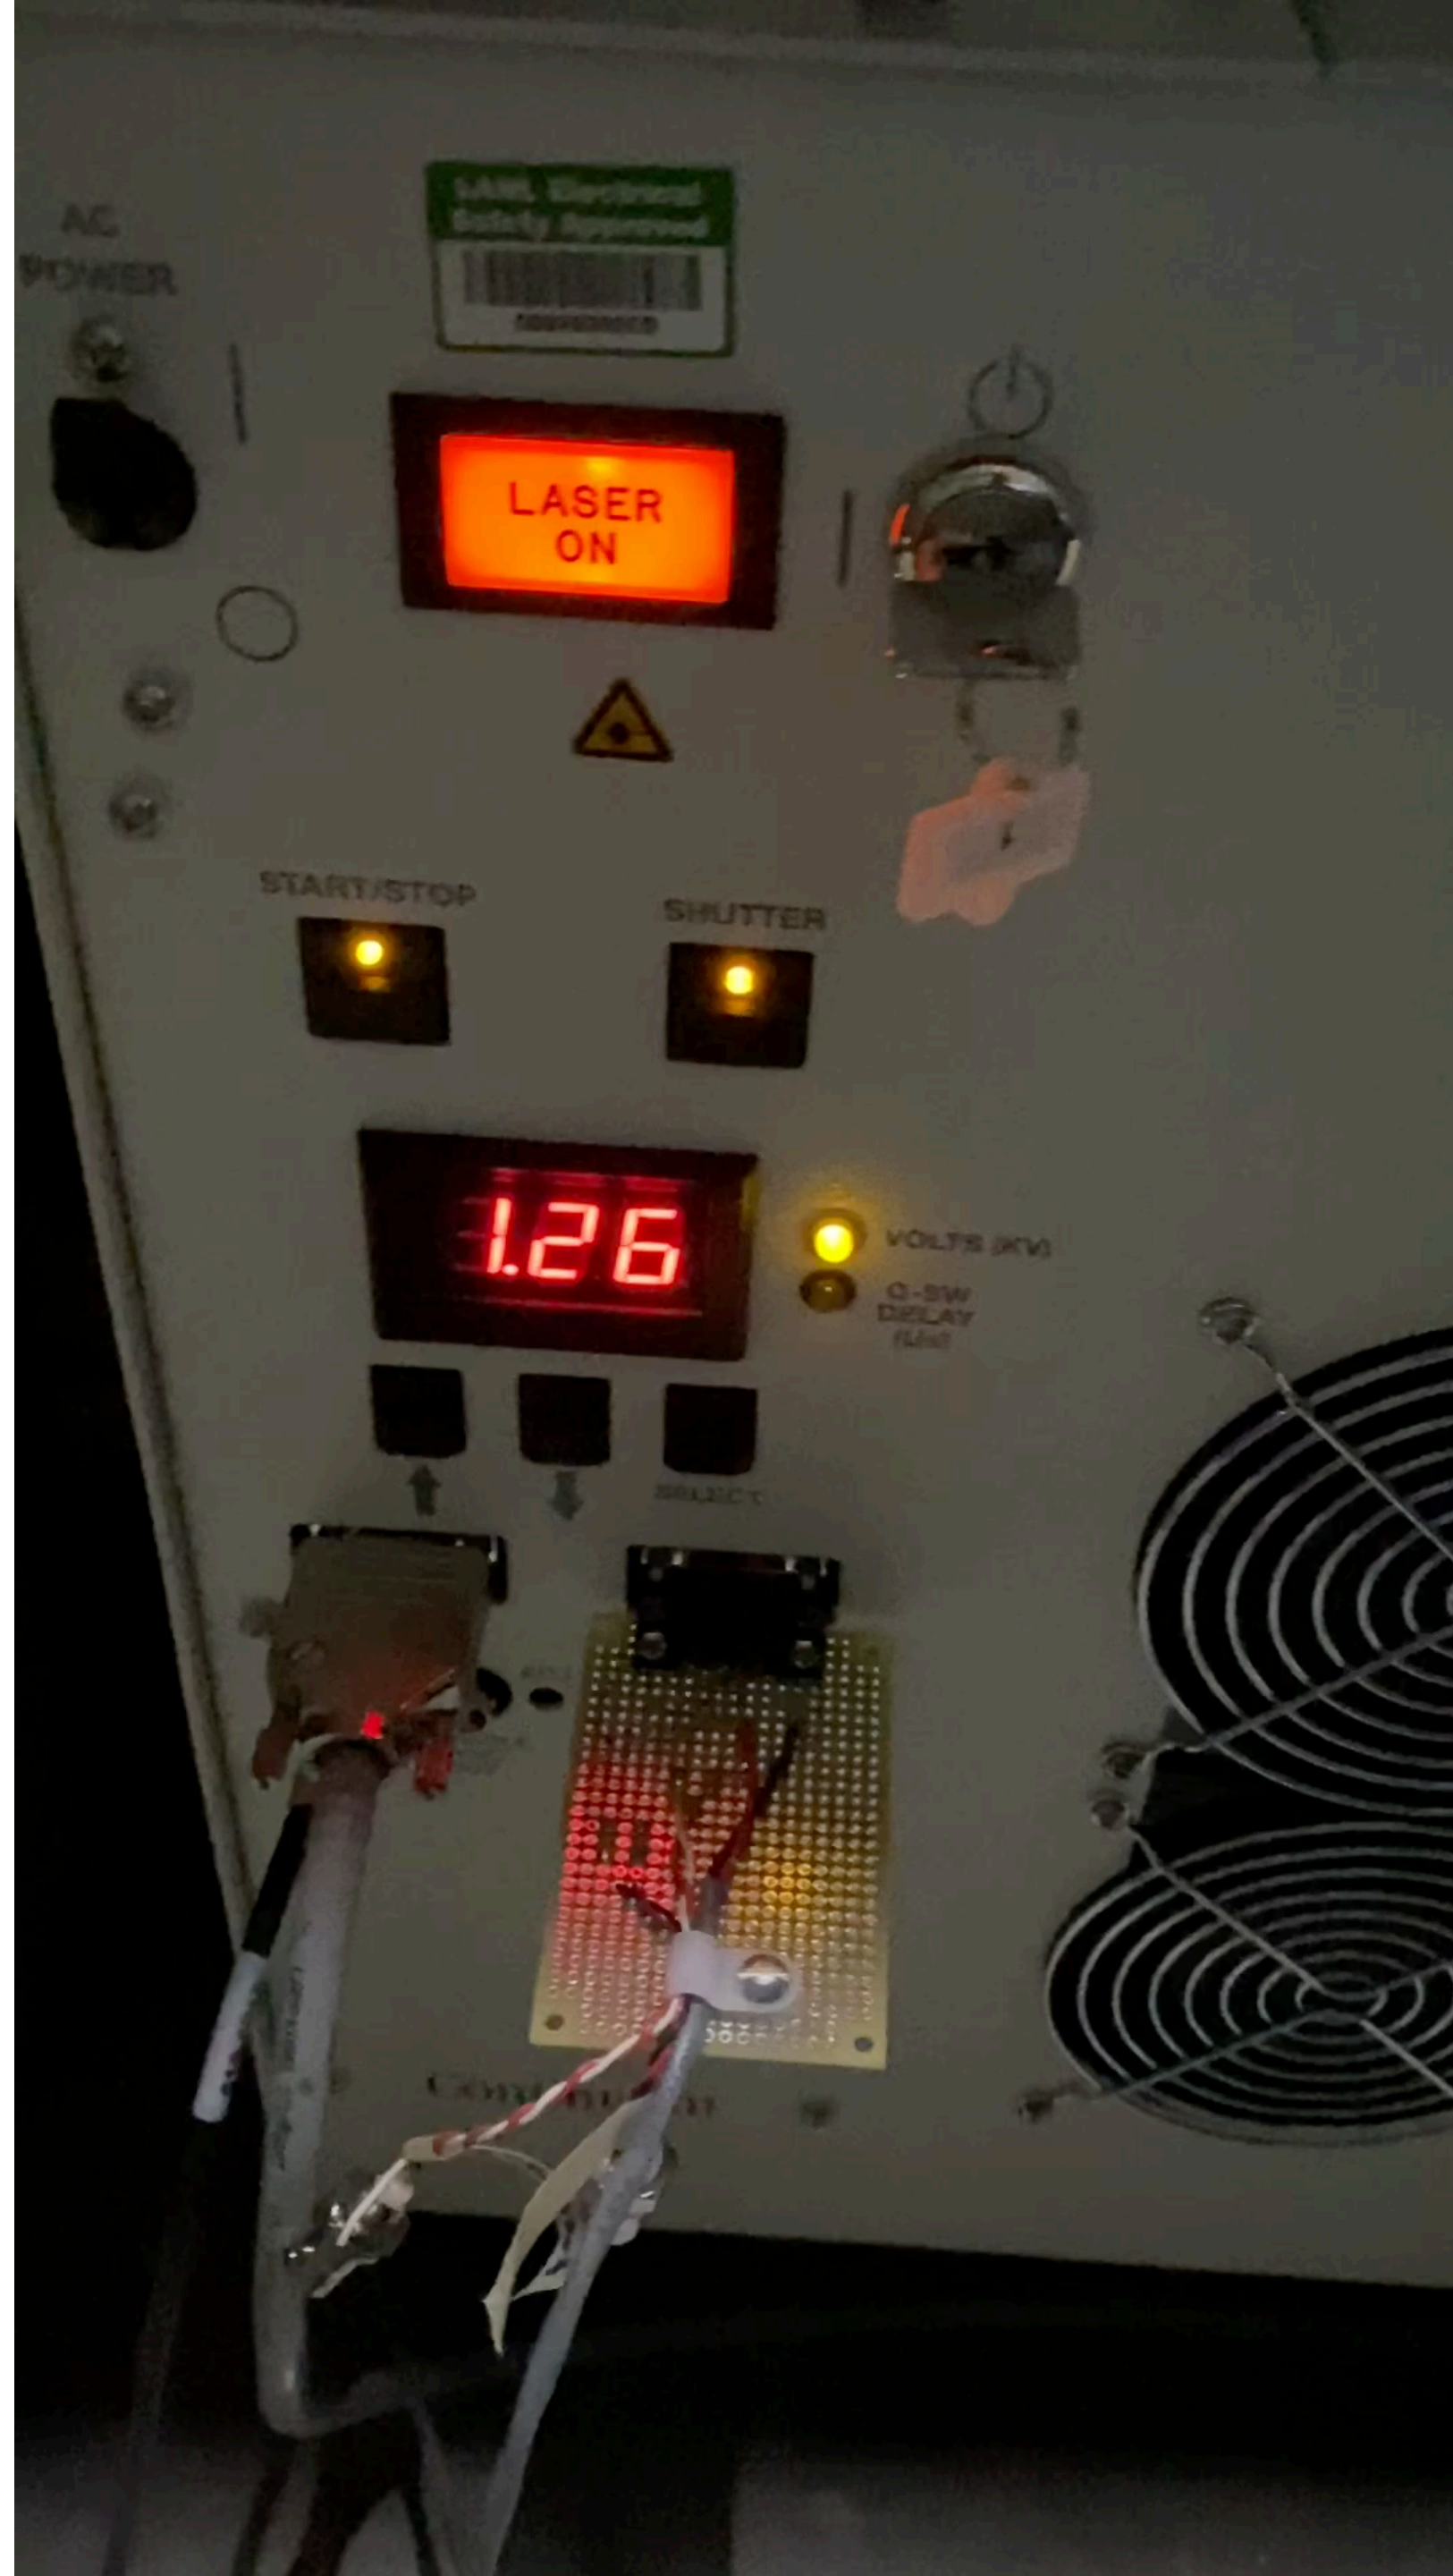
Getting UV laser as close as possible to the edge

Alignment laser and
UV laser (pulsed)
aligned after M2
